Metal Roof

Common Roofing Issues

ASTEC Solution

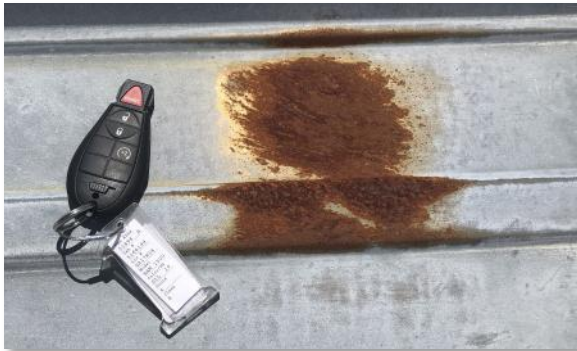
Fasteners backing out and dirt and debris buildup

Tighten/replace fasteners and pressure wash and clean

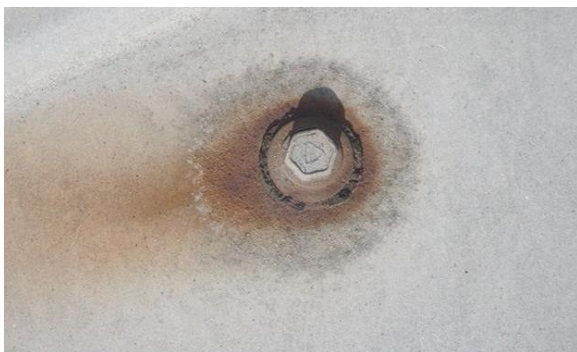
Rust

Treat rust to prevent further rust formation

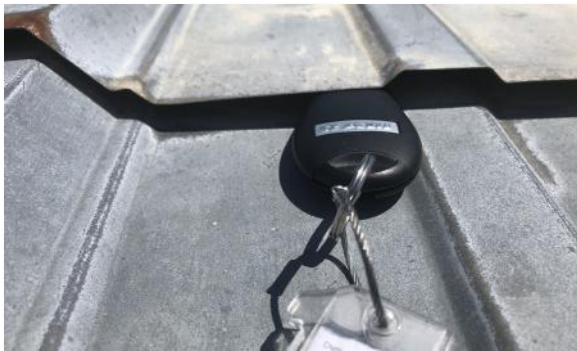
Failing fastener grommet

Encapsulate and waterproof fasteners

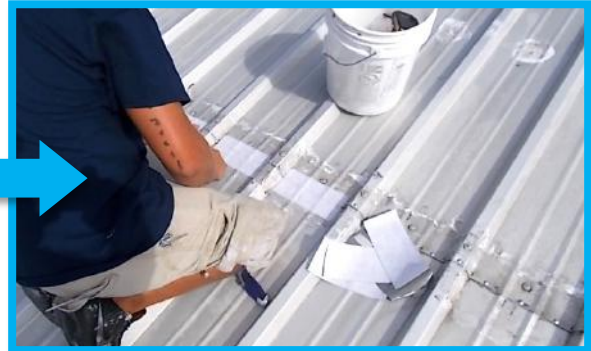
Fully reinforce horizontal seams

Horizontal seams separating

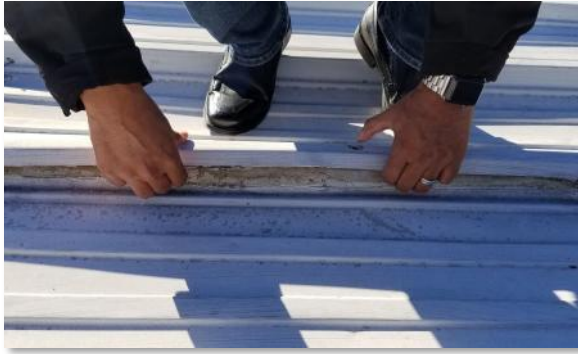
Vertical seams separating

Fully reinforce vertical seams

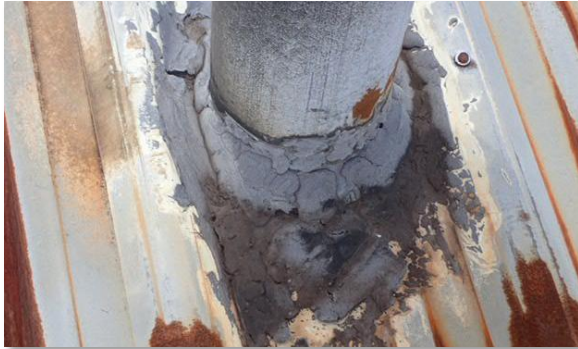
Failing penetrations

Seal and waterproof penetrations

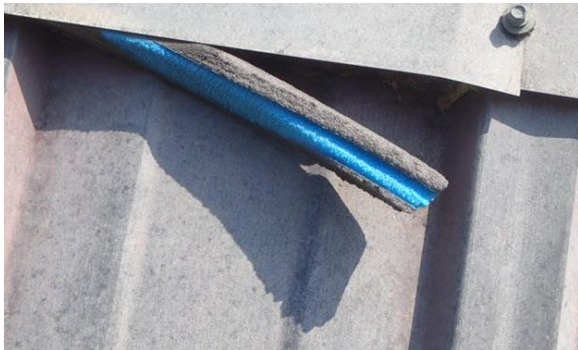
Loose or missing foam inserts

Foam, trim, seal and waterproof open voids

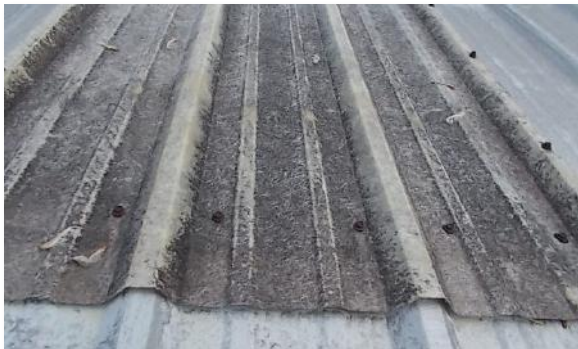
Deteriorating skylights

Rejuvenate fiberglass skylights

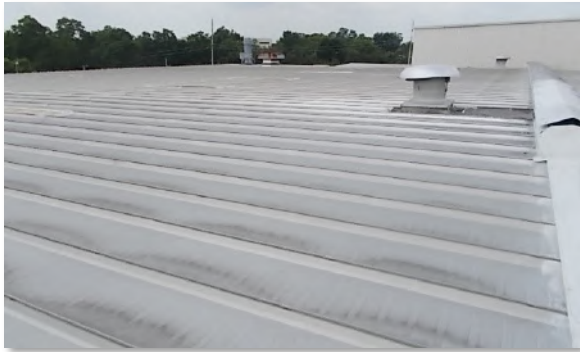
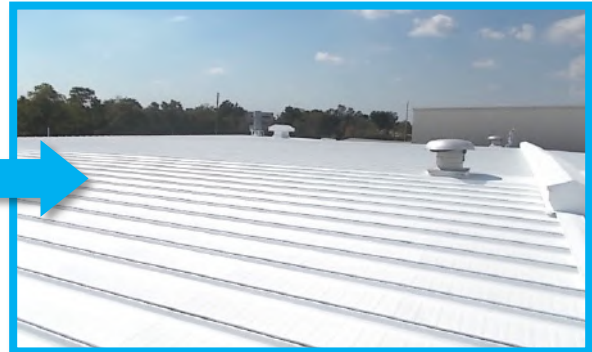
Entire roof receives multiple coats of ASTEC Finish

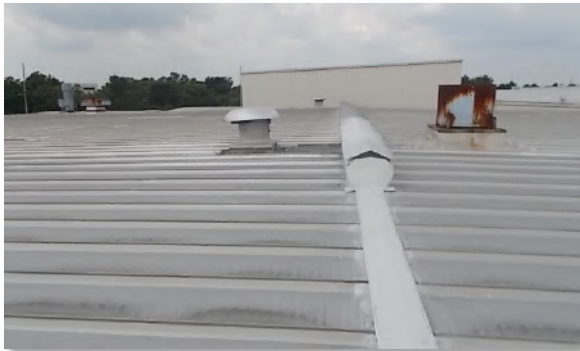
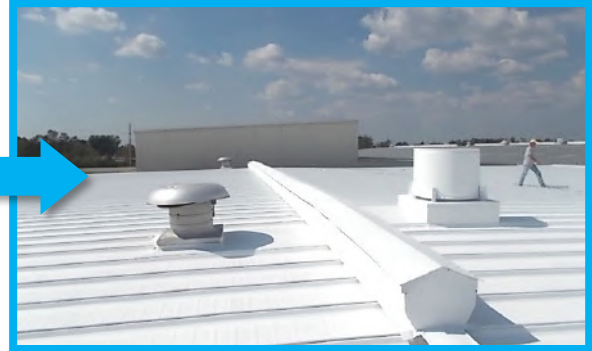
Seamless monolithic system
